**SANITARY WARE SPECIFICATION SHEET**

Item Descriptions	American Standard (PRC) "Lux" Chrome plated wall mounted sensor faucet (Integrated) top access replacement of batteries; DC supply; nominated flow rate <b>3.4 l/min</b> in WELS Grade 2; Registration No. TN 18-0032
Dimensions	238mm long projection
Model	CF-8837.000.50 (Mixer) 40.7458.010 (Aerator)
Finish	Chrome Plated
Manufacturer	American Standard (PRC)
Source	Acme Sanitary Ware Co. Ltd Mr. Eric Wong/ Mr. Wilson Hung
Contact Tel/Fax	(852) 2388-7171 / (852) 2710-8012
E-mail	acme@acmesanitary.com.hk
Website	www.acmesanitary.com.hk

**Approval of “AMERICAN STANDARD” Sensor Tap  
(General Acceptance No. C20200803)**

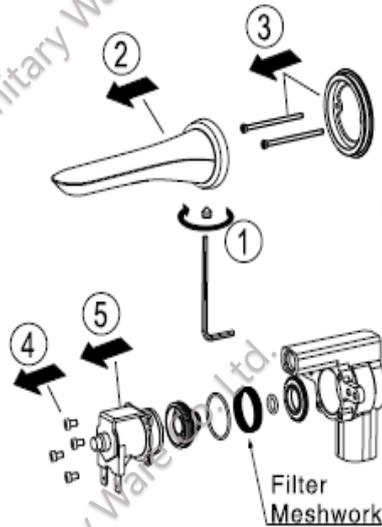
CF-8837 / CF-8838

The Stop Valve of this sensor faucet has equipped with good quality filter, But the impure water or impuring in the water pipe will affect the water flow, in this condition, you should clean the filter, the process is as below:

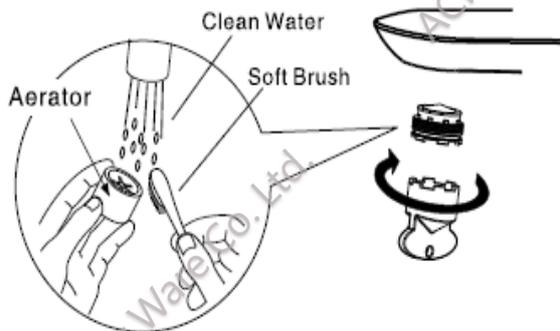
If necessary, you could clean the aerator too as per below step

- 1). Screw off the Aerator from the Spout.
- 2). Clean the Aerator with water.
- 3). Reinstall the Aerator to the Spout.

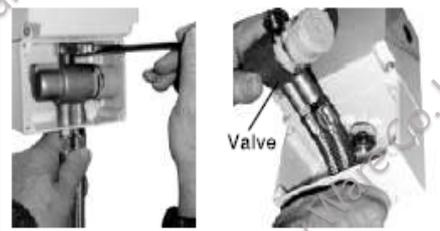
1. Open the Box, Take out the Valve

\* If you want to change the parts or clean the inner of Temperature Calibration Unit, Please follow the steps in the above to remove the parts, then proceed the next steps.

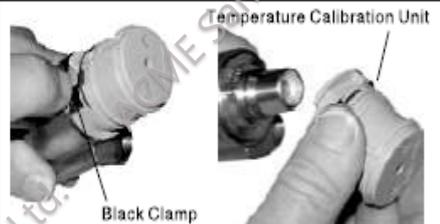
2. Take out the Black Clamp and Temperature Calibration Unit

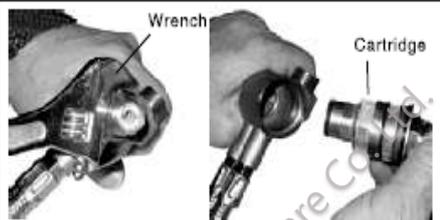
3. Turn-on Cartridge

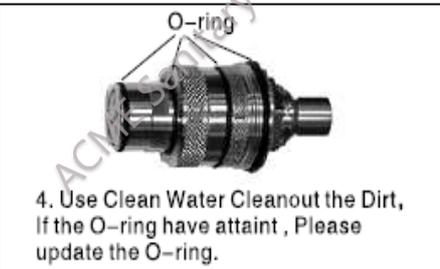
4. Use Clean Water Cleanout the Dirt, If the O-ring have attaint , Please update the O-ring.

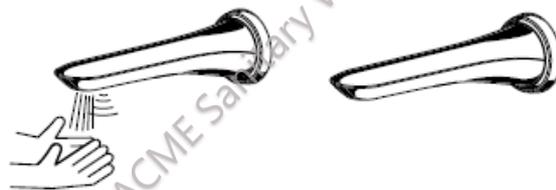
Put hand into the sensor window, Sensor detects and water come out automatically

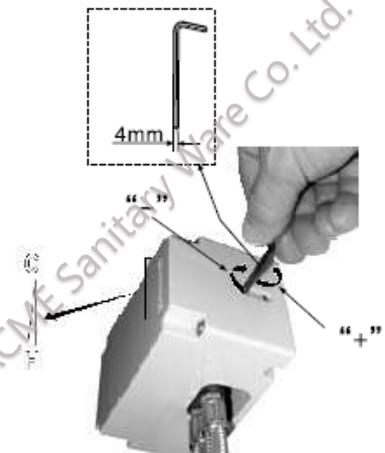
Adjustment the Temperature Calibration Valve

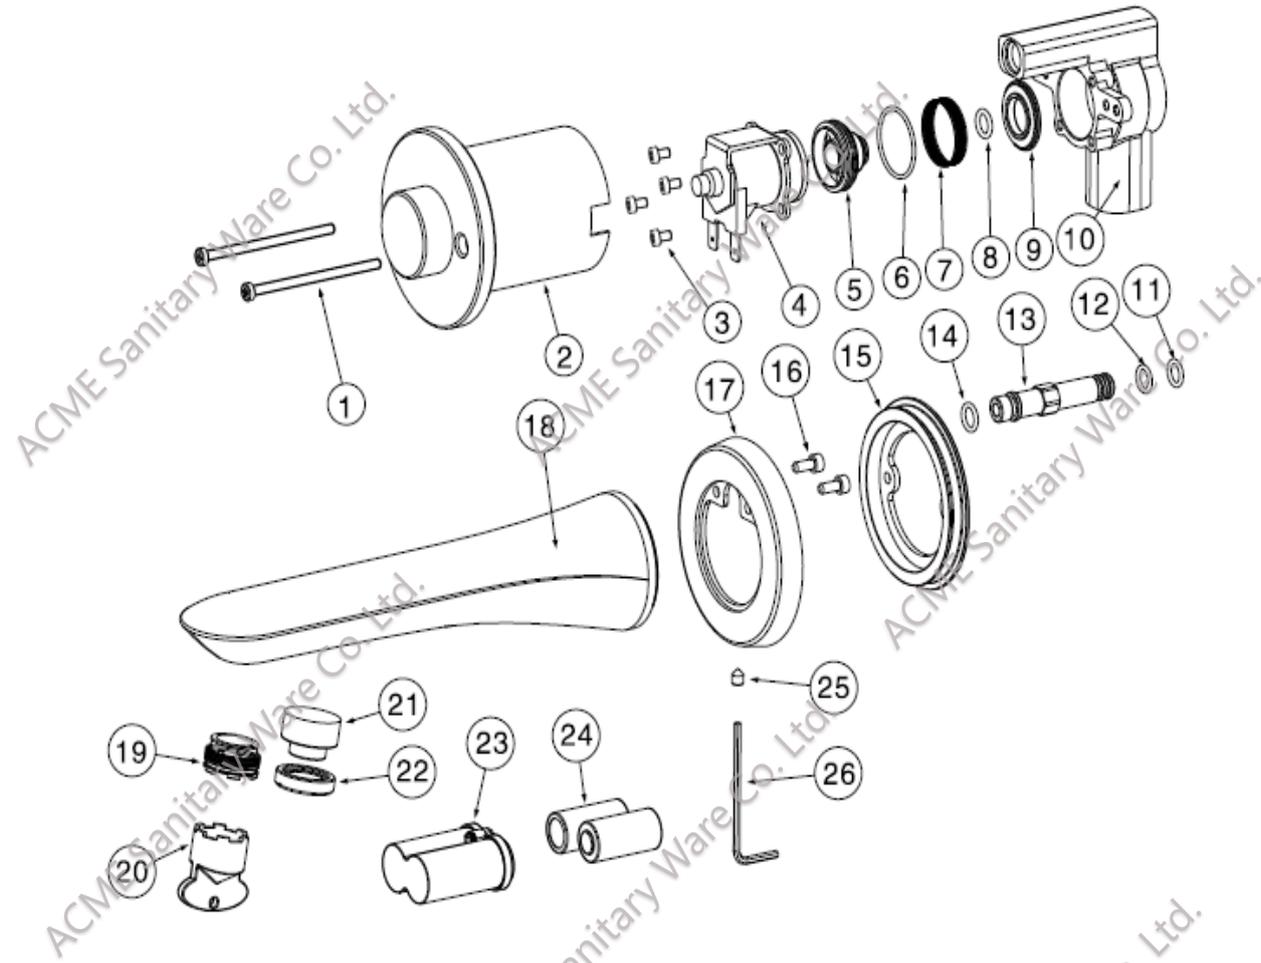
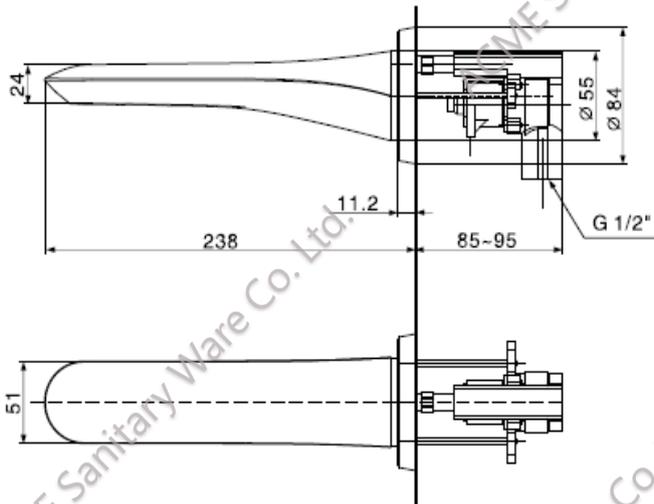
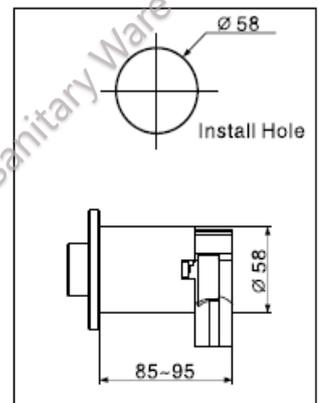
Parts List / Dimensions (CF-8837.000.50)

Parts List	No.	Part Noame	Q'ty	No.	Part Noame	Q'ty
	1	Screw	1	14	O-Ring	3
2	Plaster Guard	1	15	Seat	1	
3	Screw	4	16	Screw	2	
4	Solenoid Valve	1	17	Escutcheon	1	
5	Seat	1	18	Spout	1	
6	O-Ring	1	19	Aerator	1	
7	Filter Meshwork	1	20	Wrench	1	
8	O-Ring	1	21	Sensor	1	
9	Seat	1	22	Nut	1	
10	Control Body	1	23	Battry Box	1	
11	O-Ring	3	24	battry(3V)	2	
12	O-Ring	3	25	Screw	1	
13	Linker	1	26	In-hex Wrench	1

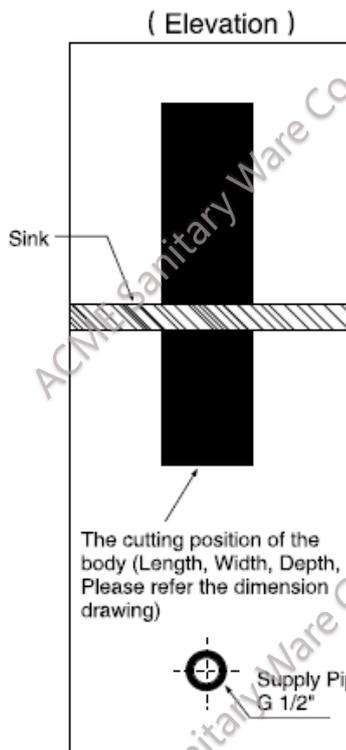
- ① Consult the dimension drawing and confirm the position of the body and pipe;  
Cut the rabbet of the body's position.

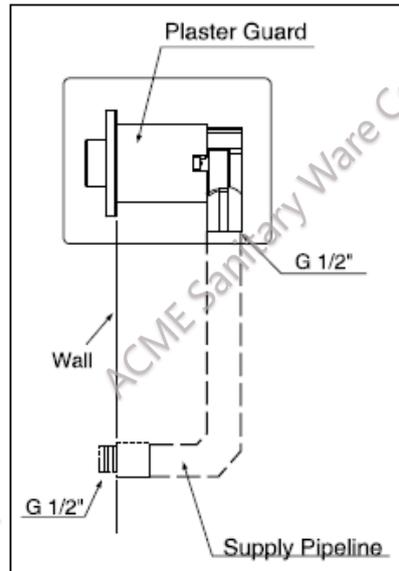
- ② Connect Pipeline to the body.

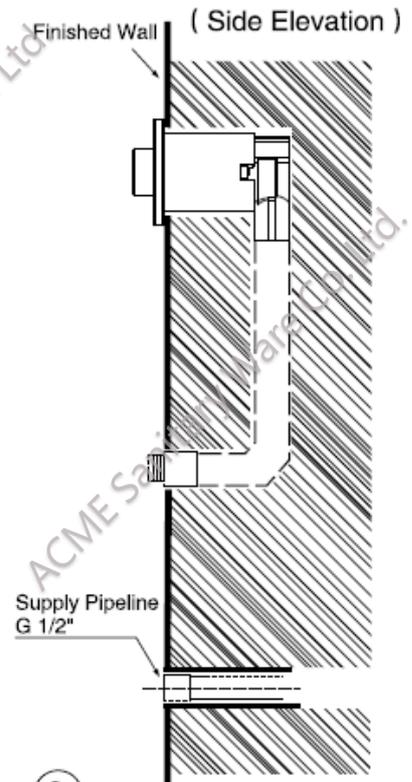
- ③ Install the pipes in the rabbet with the well connected pipes.  
Make sure there is no leakage and then repair the wall.

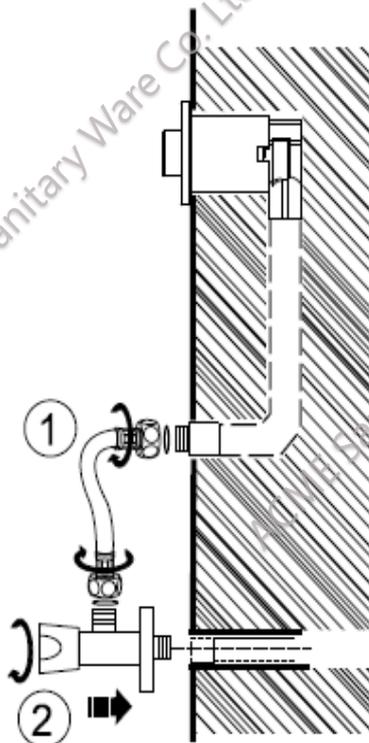
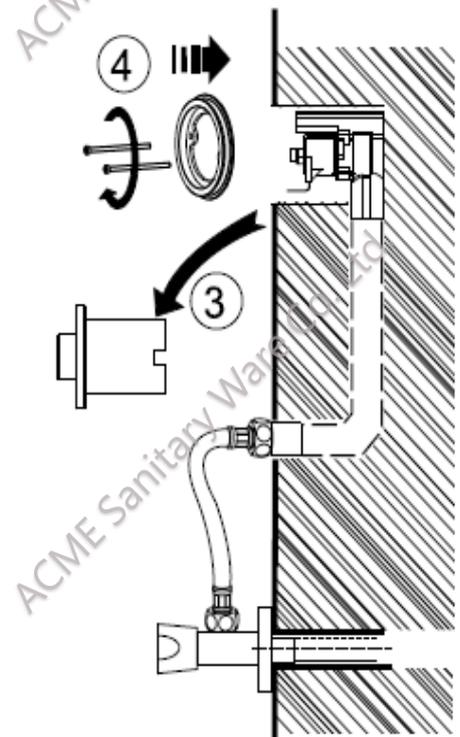
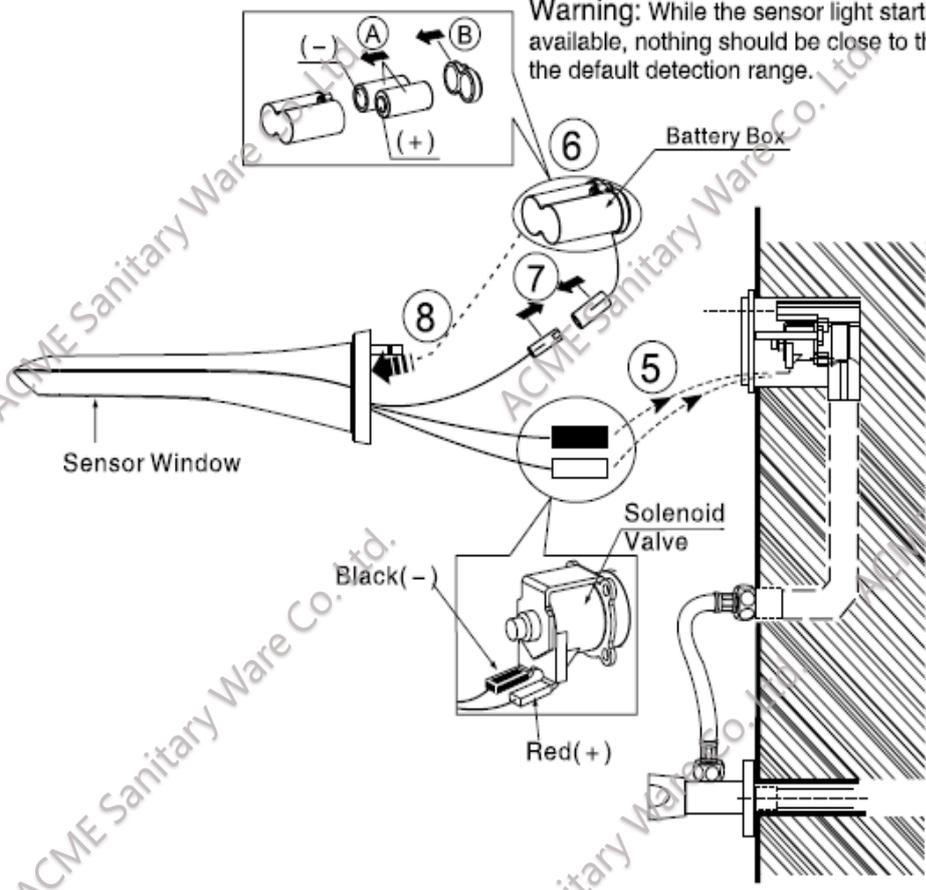
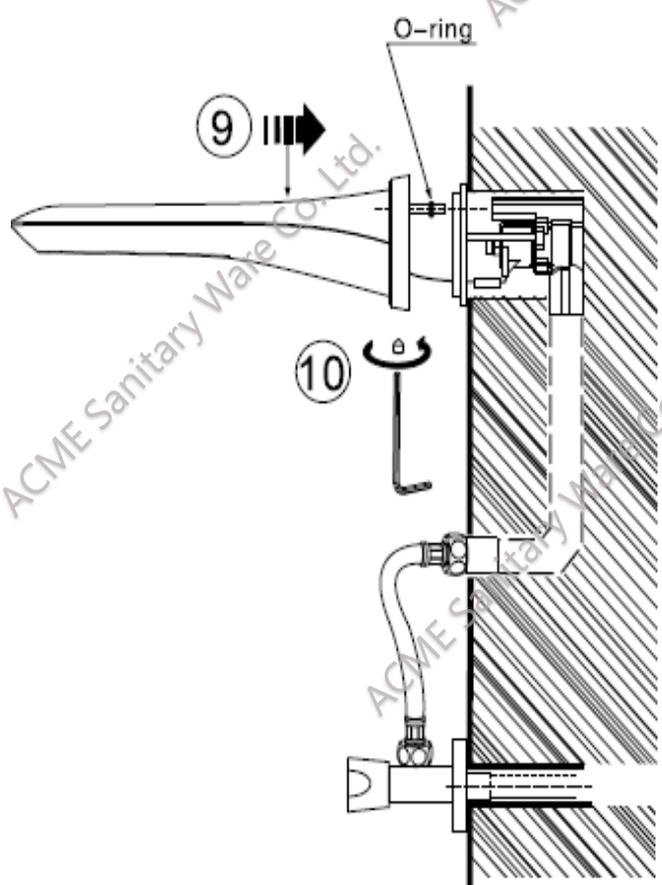
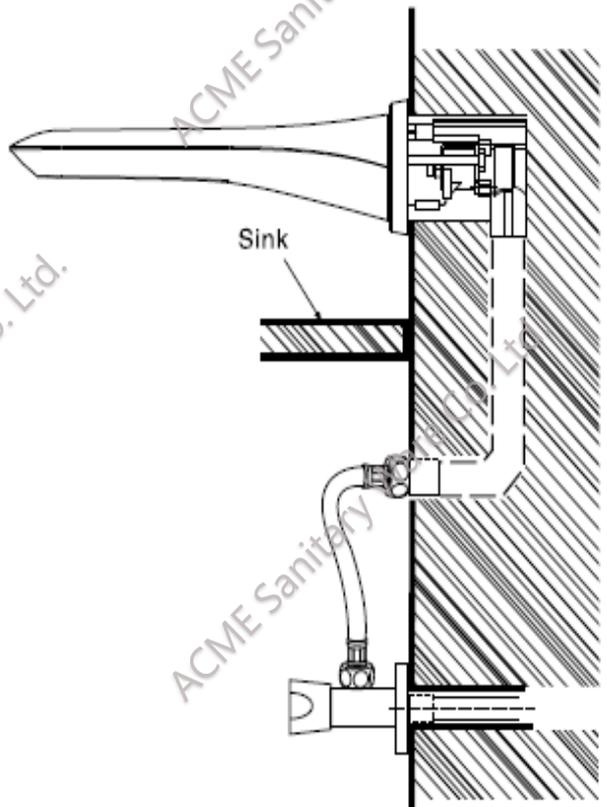
**4** Install (CF-8837)

Warning: While the sensor light starts flashing after power is available, nothing should be close to the sensor to avoid changing the default detection range.
