SANITARY WARE SPECIFICATION SHEET

Approval of "NOBILI" Sensor Mixer (General Acceptance No. C20210040)

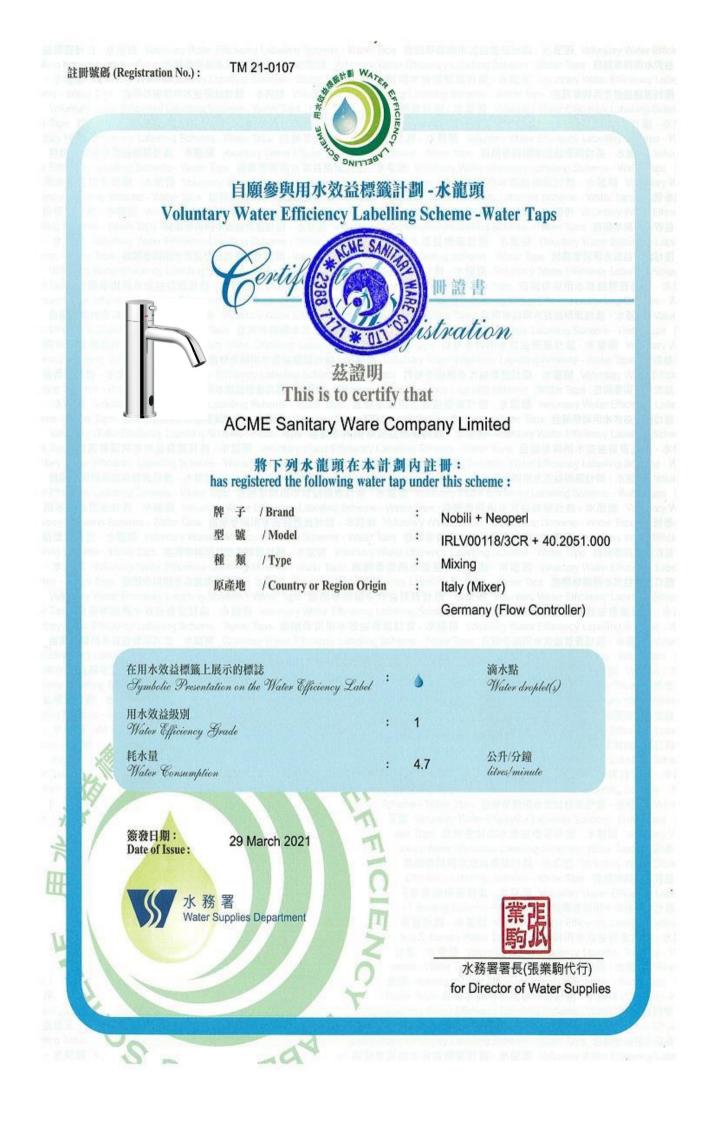
Item Descriptions	Nobili (Italy		.			Illustration/ Drawing
	sensor mixe					用水效整模面
	Supply; nor					Efriciency Label
	WELS Gra	de 1 ; Re	egistratio	on No. T	M 21-	
	0107					
Standard	QAVR (Ital	y)				
Dimensions	L110 x W5) x H17	1 mm			
Model	IRLV00118	/3CR				
Finish	Chrome Pla	ted				
Manufacturer	Nobili (Italy	7)				
Source	Acme Sanit	ary War	e Co. Lt	d		0248
	Mr. Eric W	ong/ Mr	. Don Y	uen		
Contact Tel/Fax	(852) 2388-	7171 / (852) 271	0-8012		
E-mail	acme@acm	esanitar	y.com.hl	ĸ		
Website	www.acmes	anitary.	com.hk			·유· 바 110

6.00						× .
5.00						
E .m		\sim				
. <u></u> 4.00						
3.00						
L 4.00						$G_{3/\rho}$
≗ 2.00						
1.00						Product Descriptions
0.00						infrared control

0.00 0 100	200	300	400	500	600	· Chrome
	Dynamic flo	w pressur	e (kPa)			Anti limescale aerator M22x1Battery power
Dynamic flow pressure (kPa) 50	150	250	350	500	Without waste
Flow rate (1/min)	2.55	4.55	5.05	4.40	4.80	• Ø 3/8" stainless steel flexible pipe
